INVESTIGATION OF CONCRETE DETERIORATION  
IN CERTAIN BRIDGES  
IN THE ROCHESTER, NEW YORK AREA

ENGINEERING RESEARCH SERIES  
RESEARCH REPORT RR 63-4

An Investigation by  
NEW YORK STATE DEPARTMENT OF PUBLIC WORKS  
Bureau of Physical Research  
*In cooperation with*  
U.S. DEPARTMENT OF COMMERCE  
BUREAU OF PUBLIC ROADS

# INVESTIGATION OF CONCRETE DETERIORATION IN CERTAIN BRIDGES

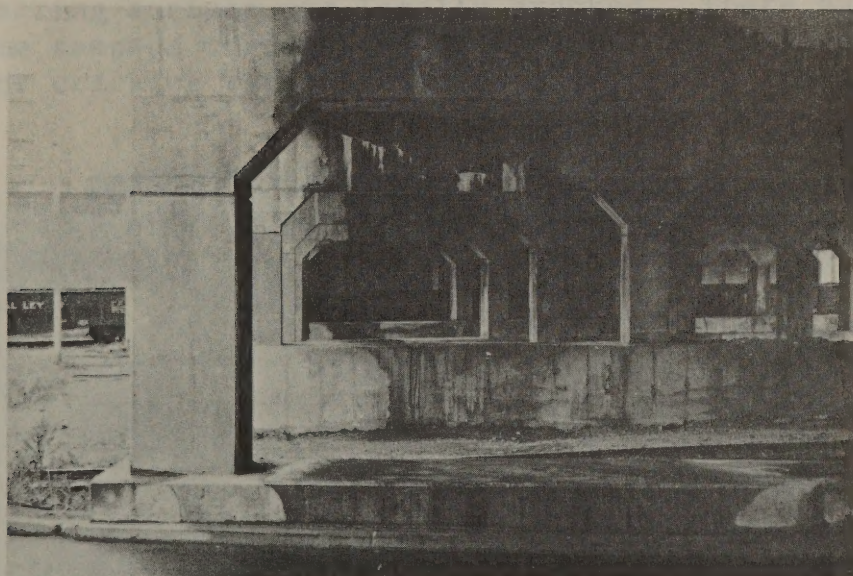
The piers and abutments had been extensively patched, but showed signs of continuing disintegration. Concrete distress in the understructure was, and has been, most prevalent where water has drained from the deck over pier headers and footings (Figure 1).

Figure 1 - Troup St. - Howell St. Bridge  
Looking east from Pier F

Extensive patching of headers and footings has been necessary in nearly every bay. The light colored material seen in Figure 1 exuding from cracks in Pier E was frequently observed in areas of distressed concrete. Chemical analysis of this material indicates that it is principally calcium carbonate with some sodium chloride. Light brown stains were noticed on some concrete of this bridge as well as on others. These stains were noted only in areas exposed to moisture and frequently in association with incipient cracking. No significance was attached to these other than the fact that they indicated the presence of iron compounds in the drainage.

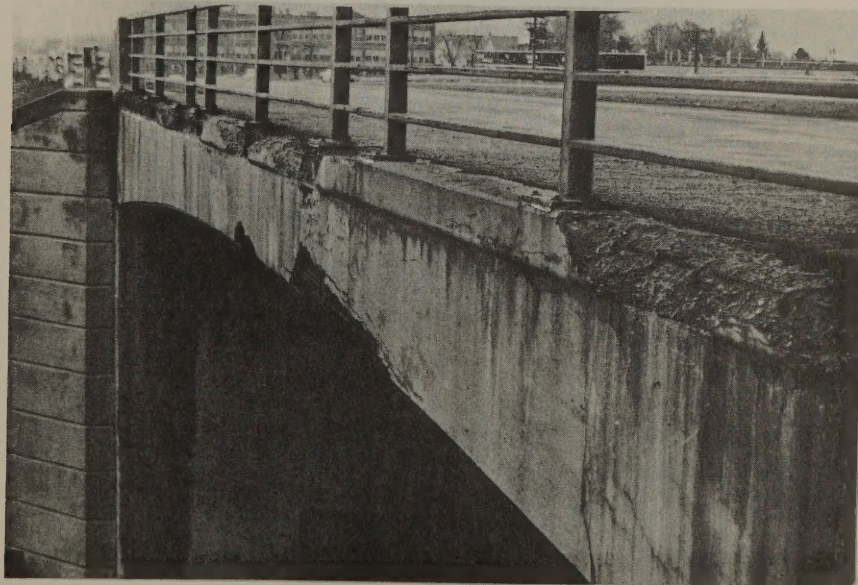
Mount Read Blvd. over N.Y.C. RR - The east sidewalk and curb previously had deteriorated to the point where surfacing with a bituminous mix had been required. The east fascia (Figure 2) was also severely damaged and showed abundant water stains. The west curb, sidewalk, and fascia, on the other hand, were relatively free from damage. The concrete median island had scaled to a moderate degree.

Ponded water was observed on the bridge deck, and the bituminous wearing surface was locally cracked. There had apparently been some seepage through the deck as evidenced by water stains and minor cracking beneath reinforcing bars on the underside.

Figure 2 - Mt. Read Blvd. over N.Y.C. RR  
Looking south along east fascia

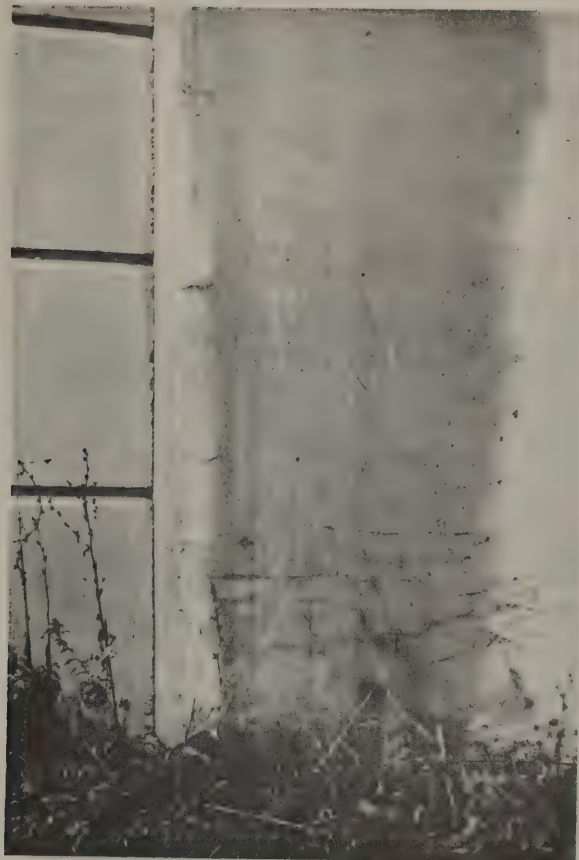
In general, the abutments and wing walls were in excellent condition, except for some cracking on the east side of the south abutment (Figure 3). As with the Troup St. - Howell St. Bridge, most deterioration was associated with the presence of an abundance of water. Some pitting was observed in association with what appeared to be a red sandstone fine aggregate. This was particularly evident on the east end of the north abutment.

Figure 3 - Mt. Read Blvd. Br. over N.Y.C. RR  
View of east end of south abutment  
adjacent to wing wall.

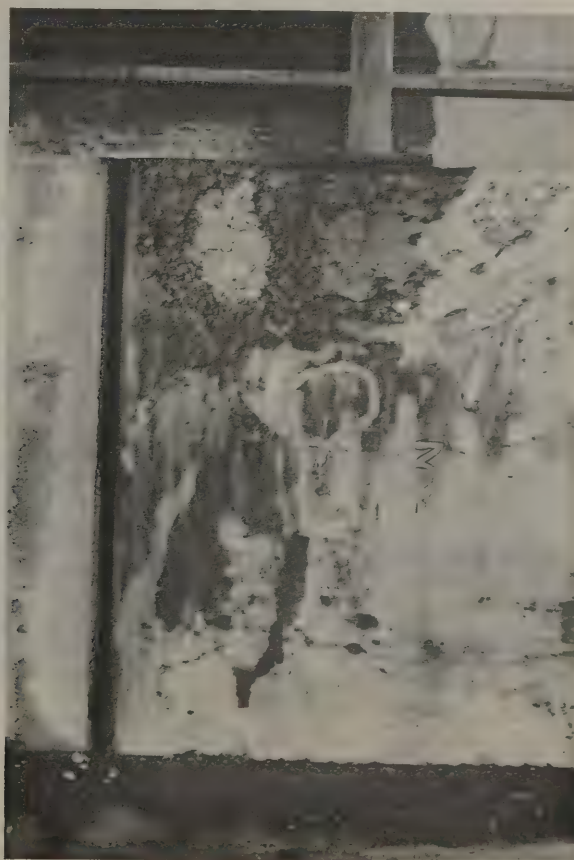
Mount Read Blvd. under B & O RR - In general, this bridge was in very good condition. Three small areas of scaling were observed adjacent to joints in the sidewalk retaining wall. The largest of these areas is shown in Figure 4. All scaled areas were in the path of water which was observed flowing across the sidewalk and down the face of the wall. In contrast to this, where drainage was evident over the face of the abutment (as seen in Figure 4 behind the railing), no distress was noted. Small areas of incipient cracking were observed in the north-west wing wall and in the center pier. A few popouts of a laminated coarse aggregate were observed in the sidewalk retaining walls. The almost complete absence of distress in the abutments pier and wing walls may be due to the fact that it is a railroad overpass with the consequent absence of deicing chemicals in water that drains from above. The sidewalk retaining walls, on the other hand, are adjacent to the roadway and are undoubtedly salted by splashing.

Figure 4 - Mt. Read Blvd. Br. under B & O RR  
View of east sidewalk retaining wall.

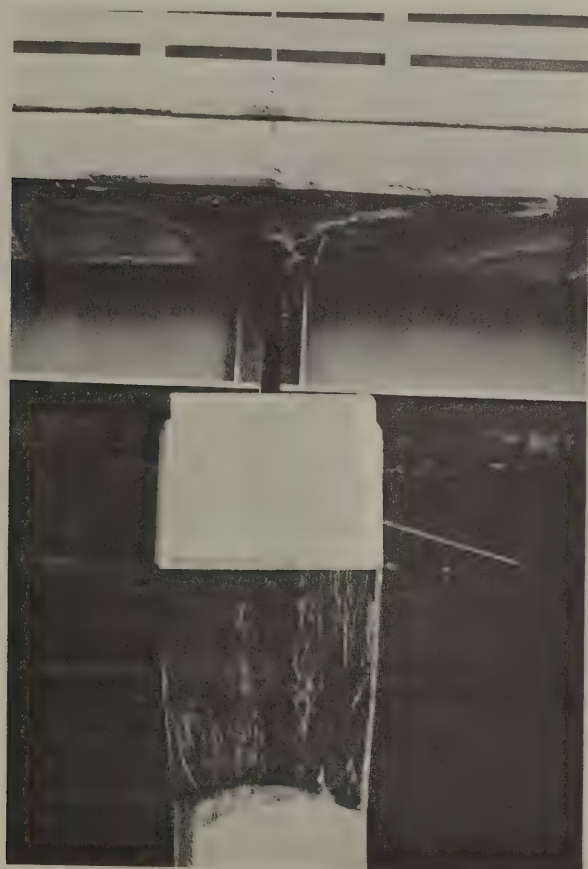
Mount Read Blvd. under Ridgeway Ave. - The deck of this bridge was in fairly good condition, except for some damage adjacent to transverse joints noticeable from beneath. Portions of the sidewalk and fascia had been patched. The north fascia was stained and had begun to scale adjacent to the deck joint. When the deck was cored near the joint, the surface of the structural slab beneath the asphalt wearing surface was observed to be deteriorated. The pier, which is located directly beneath the deck joint had been patched, but signs of new distress were evident (Figure 5). The abutments have been extensively damaged where water has drained through the joint between the deck and approach slabs and between the deck and wing walls (Figure 6).

Figure 5 - Mt. Read Blvd. under Ridgeway Ave.  
South face of center pier.

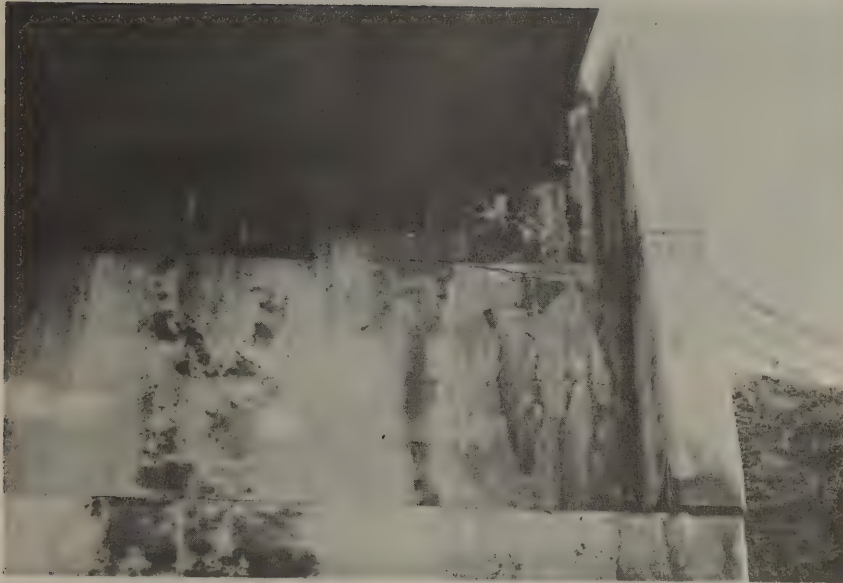
Figure 6 - Mt. Read Blvd. under Ridgeway Ave.  
North end of west abutment

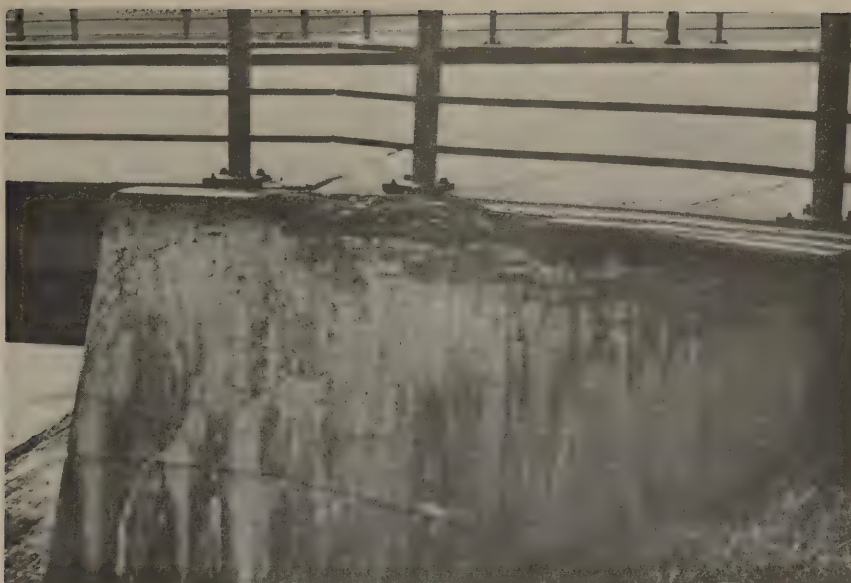
The northwest wing wall was in particularly poor condition (Figure 7). The white to gray colored deposits of calcium carbonate and sodium chloride noted on the Troup St. - Howell St. Bridge were particularly evident along the abutment back walls in association with severe disintegration. A small number of coarse aggregate popouts also were observed.

Figure 7 - Mt. Read Blvd. under Ridgeway Ave.  
Northwest wing wall.

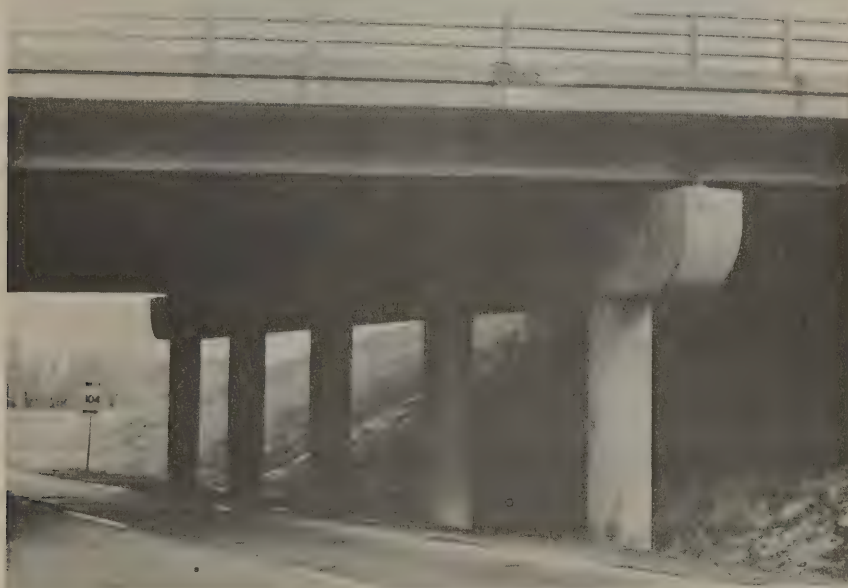
Mount Read Blvd. under Ridge Rd. - The general condition of this bridge was very similar to that at Ridgeway Ave. The deck, fascia, wing walls and abutment back walls were damaged in the same way and to about the same degree. Cores taken through the deck also showed signs of scaling on their surface beneath the bituminous wearing course. The one notable exception to this was the piers which were in excellent condition. In this case, deck slabs are continuous over their supports and water draining through the joint had not, therefore, come in contact with the piers (Figure 8). Ponding of water over the expansion joint between the deck and approach slabs was observed both at the Ridge Rd. and Ridgeway Ave. structures. This appears to be the principal source of water that drains through these joints onto the abutment back wall.

Figure 8 - Mt. Read Blvd. under Ridge Rd.  
View of east pier. Compare with  
Figure 5 which shows a bridge pier  
located beneath a deck joint.

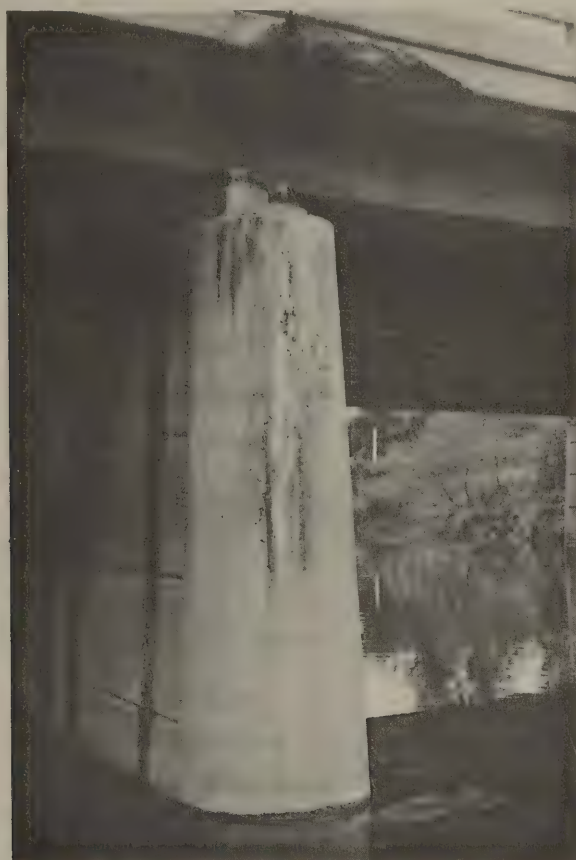
Oak St. over Tonawanda Cr. (Batavia) - Concrete deterioration in this structure was very similar to that observed in bridges (1) through (5) in Rochester, however, more shallow popouts were noted, particularly in the piers. A particle of chert was observed to be at the base of many of these popouts.

Figure 9 - Oak St. over Tonawanda Cr., Batavia  
East end of south pier.

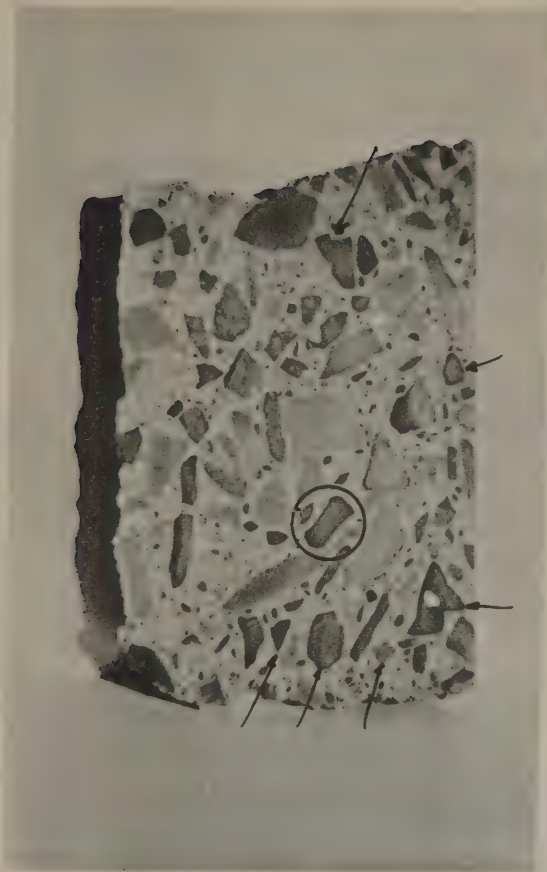
The coarse aggregate in the cores was found to consist of pieces from the Oak Orchard, Penfield, and DeCew members of the Lockport formation. Darkened rims were noted immediately within the periphery of most coarse aggregate of DeCew lithology (Figures 10 and 11). Thinner and less distinct rims were found around some pieces of coarse aggregate from the Oak Orchard and Penfield members of the Lockport but the number of these was insignificant compared to those around the DeCew. These rims

Figure 10 - Longitudinal cross section of core showing typical rimmed aggregates.

The fact remains, however, that darkened rims were noted in a large number of pieces, primarily of the DeCew lithology. These rims were found with equal frequency in cores from damaged and undamaged areas and did not appear to be associated with any recognized distress. Their presence remains unexplained but further attempts are being made to identify them.

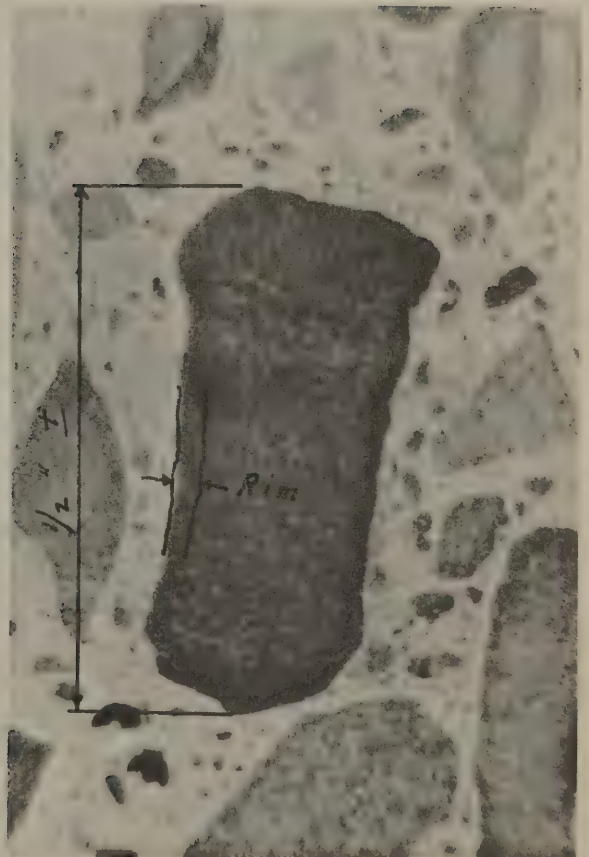
Figure 11 - Enlargement of rimmed aggregate shown circled in Figure 10.

are similar in appearance to those noted in the literature to be associated with the recognized carbonate aggregate reactions.
